RICS Home Surveys Information Sheet

RICS HomeBuyer Report

Type of property	The home is a mid terrace house. The front of the property faces approximately west.
Approximate year the property was built	1900 - Elements of the property are deteriorating through age.
Approximate year the property was extended	1960
Approximate year the property was converted	N/A
Information relevant to flats and maisonettes	N/A

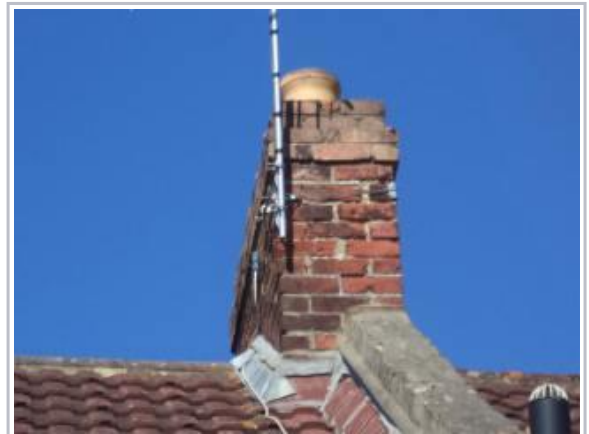
The defective mortar joints to the chimney stack should be raked out and re-pointed. Condition rating 2.

Poor pointing rear of chimney

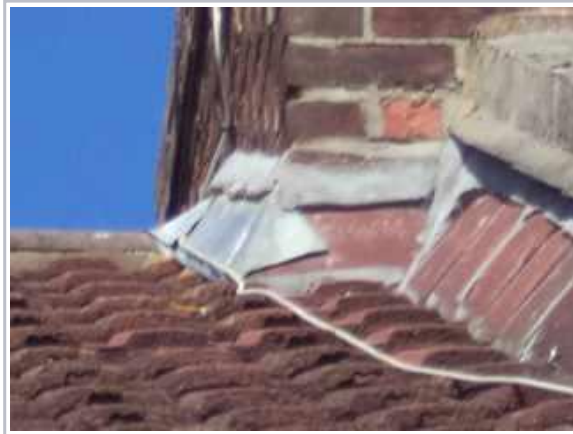
Basic tiled chimney flashings

The basic tiled flashings at the base of main chimney stack should ideally be replaced in lead throughout.

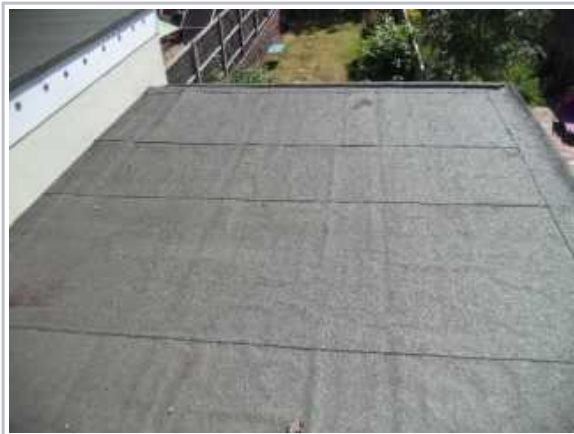
Flat roof without solar protection

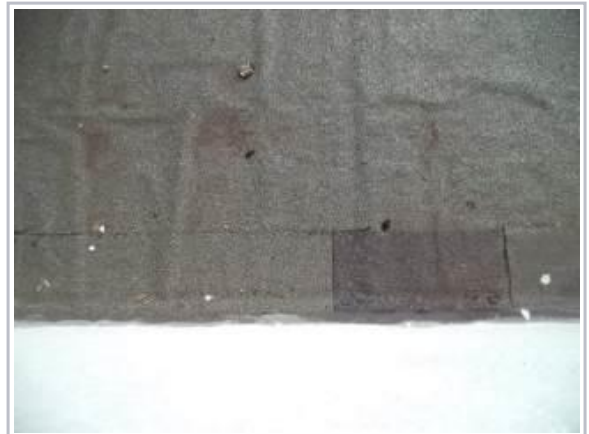
I saw no evidence of defects to the flat roofing but this has a limited life and future renewal will become necessary. The life span of a flat roof covering is difficult to predict. The surface may appear sound, but a minor surface defect can cause deterioration to the concealed timbers. Such problems can go undetected for a period of time. Flat roof coverings should be checked regularly and maintained.

Flat roof has been patch repaired

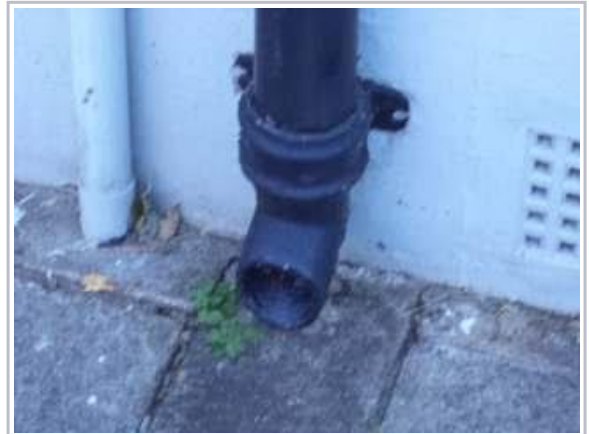
Gutter discharges onto the pavement

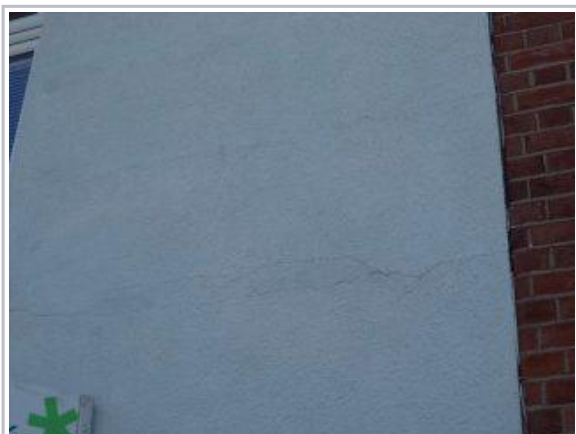
There are cracks in the walls at the front elevation which suggests that the metal ties connecting the inner and outer parts are rusting. You now need a contractor's estimate for replacing the wall ties. Condition rating 3.

Wall tie related cracks

It is possible that the cavity wall ties have been replaced on the front and therefore your legal adviser should check for any guarantees if they are available. If the wall ties have not been replaced we would recommend that an immediate inspection by a cavity wall tie specialist is carried out and any recommended works undertaken.

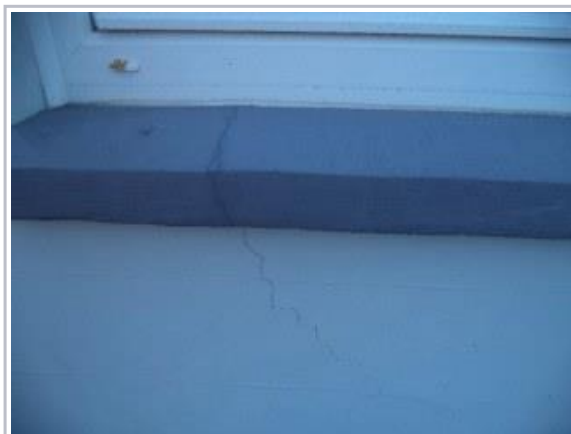
There is some defective render outside where it is cracked should be hacked off and replaced.

Defective cills to the front elevation should be repaired or replaced.

Cracked cill and render

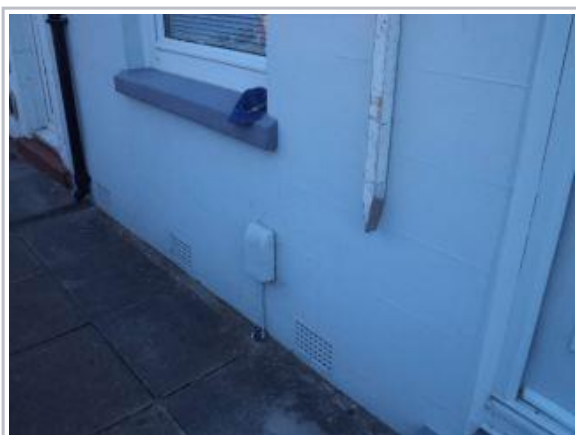
Render over damp proof course

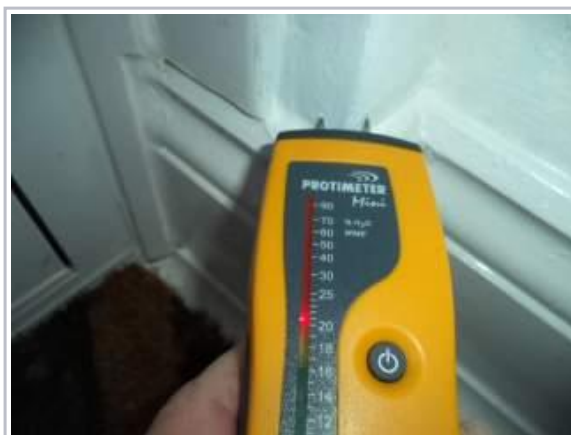
Dampness is affecting the front elevation walls. I suspect this is due to either blocked cavities or a failed damp proof course. Concealed timbers may be defective and floors should be opened up and fully investigated. You now need to instruct a damp proofing/timber treatment contractor to carry out an investigation to identify the full extent of the problem and the necessary repairs required, together with an estimate of the cost. Condition rating 3.

Damp in hall

As mentioned earlier, dampness was found to the front elevation walls particularly around the sides of the door opening and within the electrical meter box. A check by a registered preservation company would be advised with any works recommended carried out. Legal adviser should check for any pre-existing guarantees for dampness and timber treatment works carried out in the past.

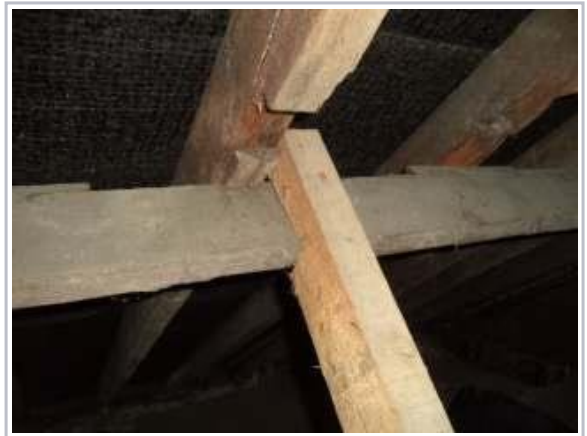
Given there is extra weight with the concrete tiles compared to the original slates, we conclude that the purlin on the front elevation is under sized and we noted that there are a number of split rafters indicating that the loading is too heavy for the current roof structure. There are inadequate struts provided for the weight of the concrete tiles. Therefore, we consider that the roof requires additional strengthening of struts and collars to be fitted by a reputable carpenter with experience of roof structural repair. Condition rating 3.

Inadequate purlin

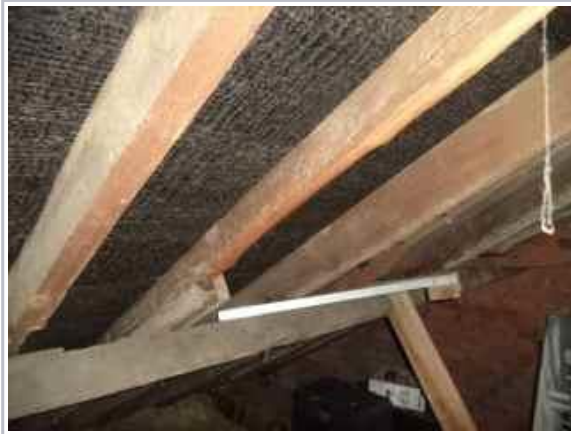
Split struts

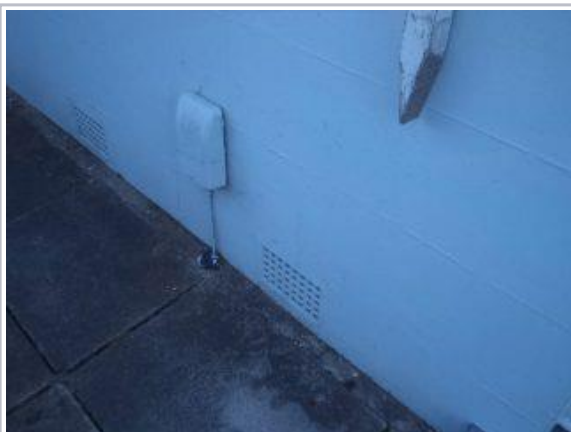
Solid flooring to the rear elevation extension restricts sub floor ventilation and additional airbricks should be provided. This may have allowed defects to occur in concealed areas and you now need to instruct a contractor to open up the floor to identify the full extent of the problem and the necessary repairs required, together with an estimate of the cost. Condition rating 3

Airbricks at front good but limited at the rear

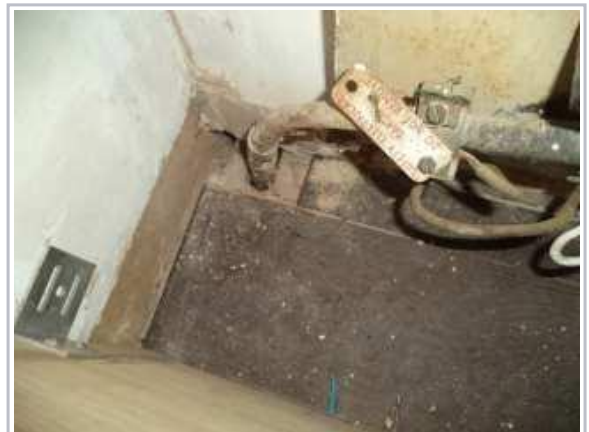
Mouse droppings were found on the floor within the electrical meter cupboard. Therefore, there is a risk that the home is subject to a vermin infestation which should be eradicated.

Mouse droppings

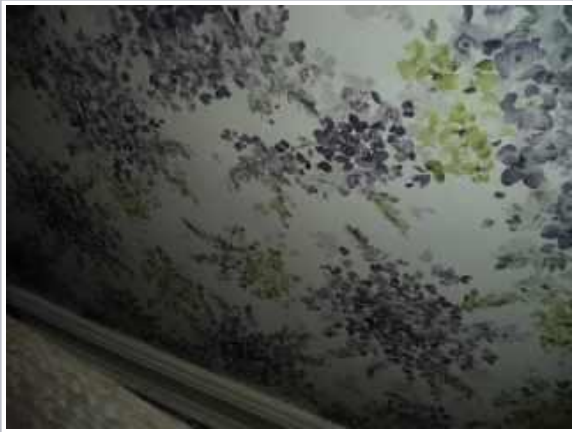
The redundant sealed flues to the unused chimney breasts should be ventilated to prevent condensation and associated defects. Condition rating 2.

Unvented chimney breast

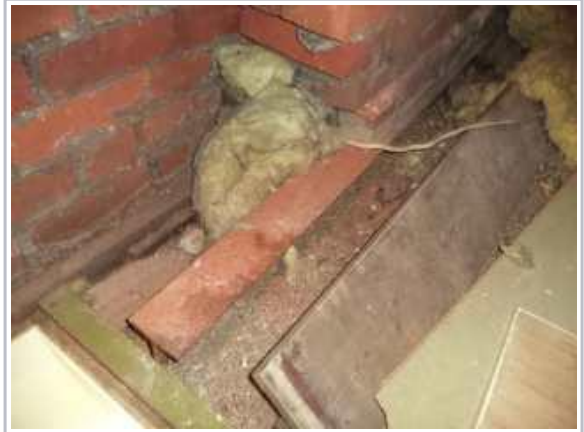
The chimney within the rear reception room and area above has been removed but is still in place within the loft. It appears that the remaining chimney breast is supported on a rolled steel joist (RSJ) which would indicate that works have been carried out in accordance with building regulations although legal advisers should check for any completion certificates.

Chimney in loft supported on RSJ

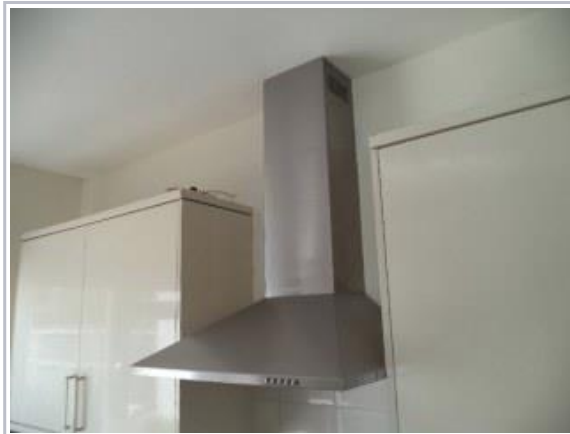
Inward venting extractor

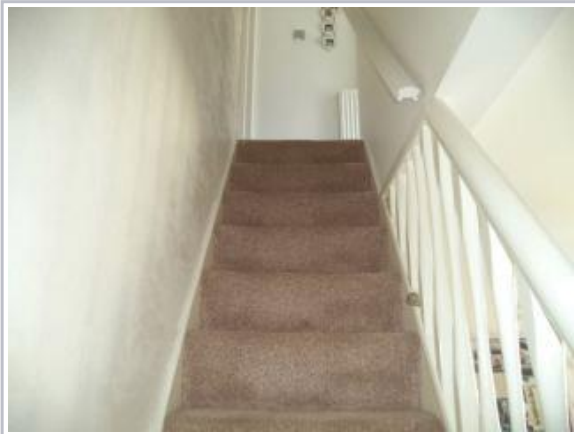
The staircase is in satisfactory condition. Care should be taken as the stairs are steep.

Steep stairs

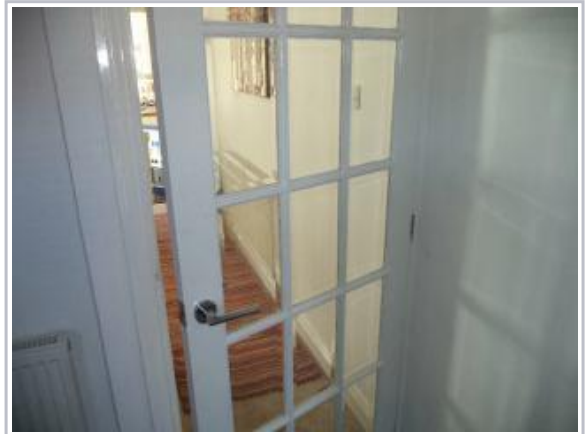
Internal doors are in satisfactory condition. The internal doors do not appear to have safety glass and replacement glazing may be required. Condition rating 2.

Glazed doors

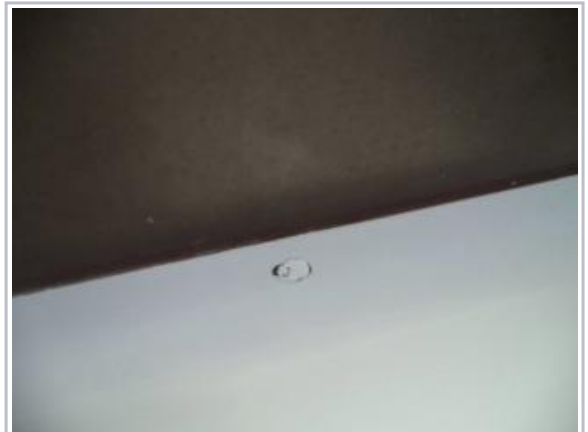
The bath enamel is damaged and should be repaired or replaced.

Chipped enamel

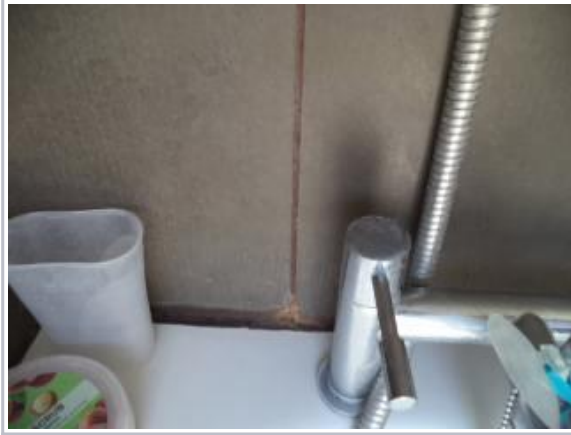
Seals around the bath are defective. This may have caused damage to concealed parts of the structure, which may need repair.

Deteriorating bath seal

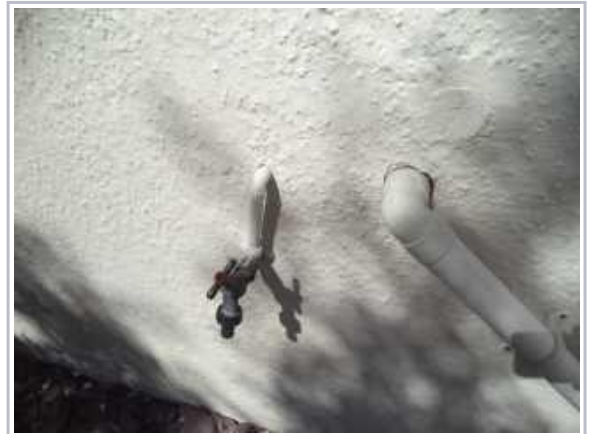
Uninsulated outside tap

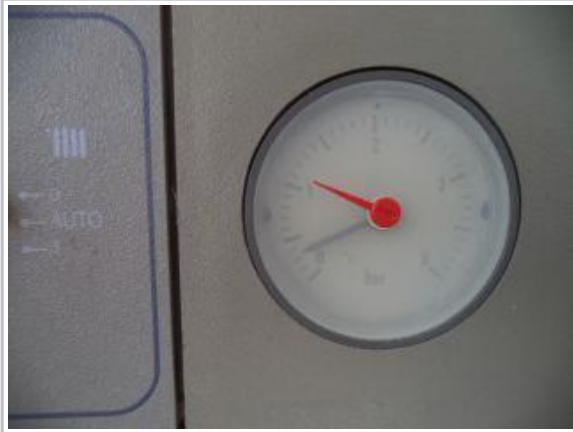
Low boiler pressure

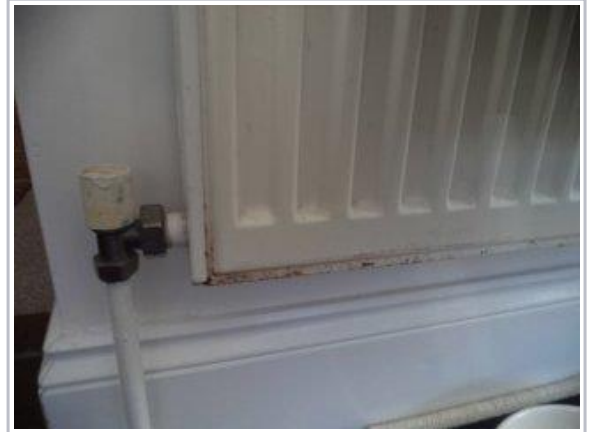
Rusting radiator

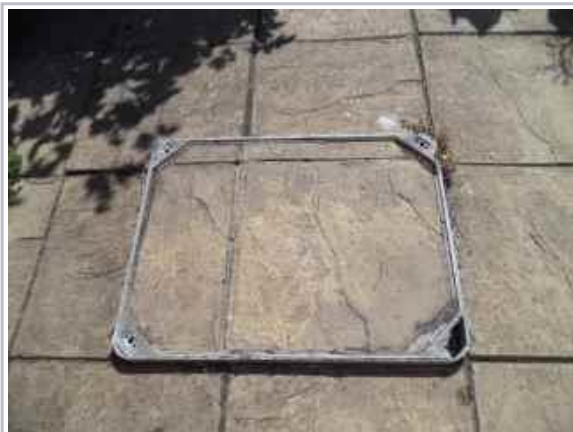
The corner of the inspection chamber cover has broken off.

Inspection chamber cover

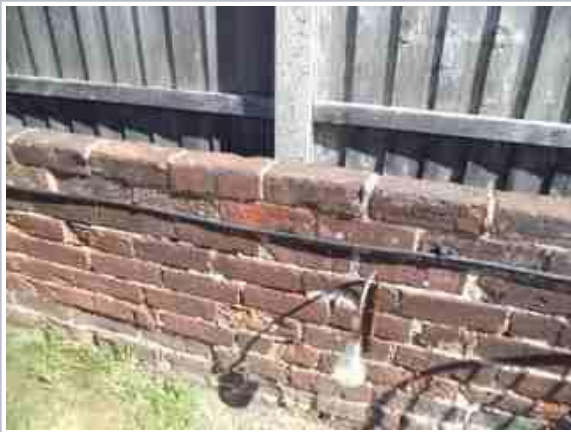
Poor boundary walls

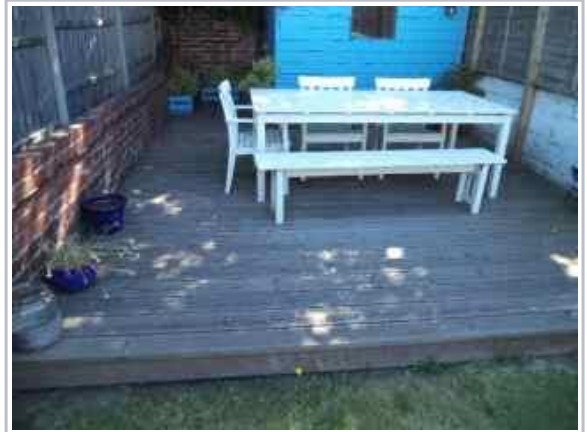
There is some timber decking at the end of the rear garden. This will become slippery when wet and be subject to decay. You should also be aware that vermin infestation, particularly rats, is common under timber decking as it provides a safe place for nesting.

Decking

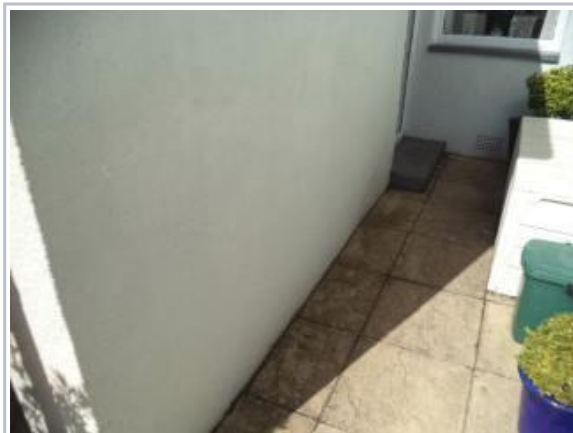
The patio is uneven and has been poorly laid.

Patio is uneven
