RICS Home Surveys Information Sheet

RICS HomeBuyer Report

Type of property	The home is a mid terrace house. The front of the property faces approximately west.
Approximate year the property was built	1900 - Elements of the property are deteriorating through age.
Approximate year the property was extended	1960
Approximate year the property was converted	N/A
Information relevant to flats and maisonettes	N/A

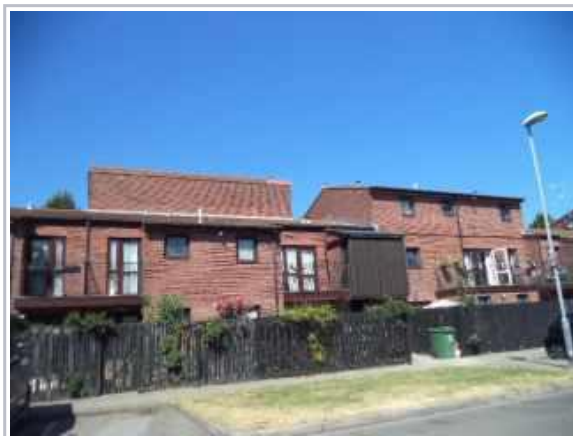
Social housing opposite

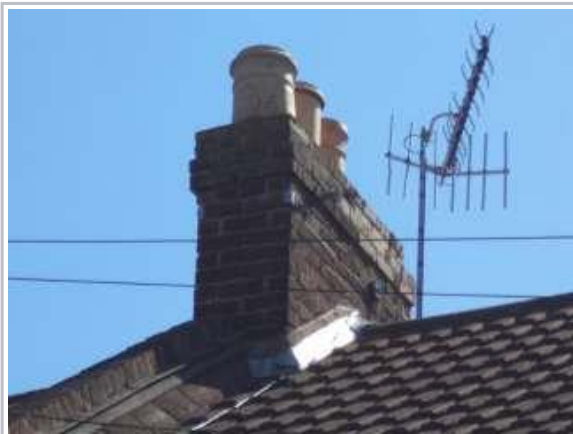
Front of chimney

The defective mortar joints to the chimney stack should be raked out and re-pointed. Condition rating 2.

The basic tiled flashings at the base of main chimney stack should ideally be replaced in lead throughout.

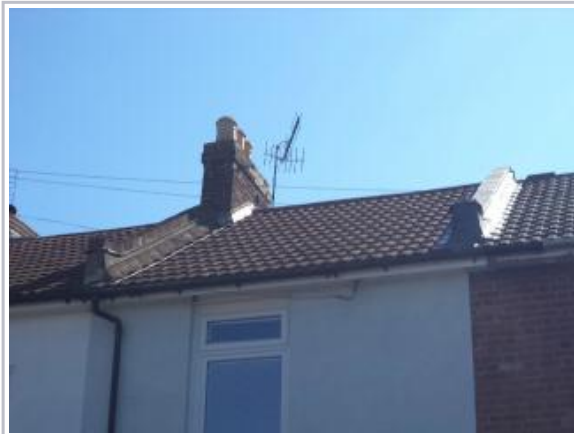
Front roof

There is evidence of minor deflection and the structure requires strengthening. This work may need to comply with building regulations and you now need to instruct a roofing contractor to provide an estimate for necessary repairs or renewal.

The original roof covering was slate and has been replaced with heavier concrete tiles. Strengthening and additional support is required and this will need to comply with building regulations. Condition Rating 3.

There are tiled flashings at the junction of the roof and the party parapet walls. These are poor in comparison to lead as they often leak after a short period of time and will require eventual replacement.

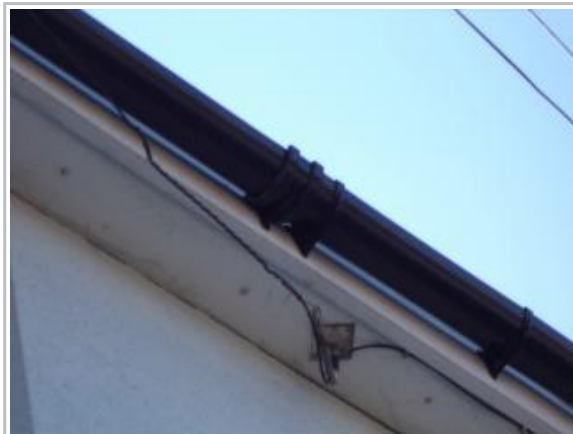
The home has PVC fascias to the outside of the roof line.
It is possible that these have been placed over the original timbers which may be suffering from decay and therefore there is a risk that the fascias could come away.
The home has painted render elevations and window cills.
External decorations are fair, but some areas are weathering. As previously advised repairs will be required prior to redecoration being undertaken.

PVC fascias

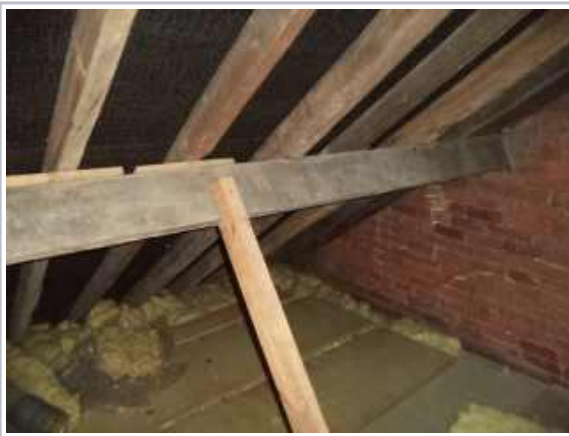
Loft

The loft void and hatch is inadequately insulated and insulation should be provided in accordance with current recommendations.

As the home was built before 1965, timbers were not pre-treated and therefore, there is a risk of decay or woodworm infestation, particularly to hard to get to hidden areas where there is limited air circulation.

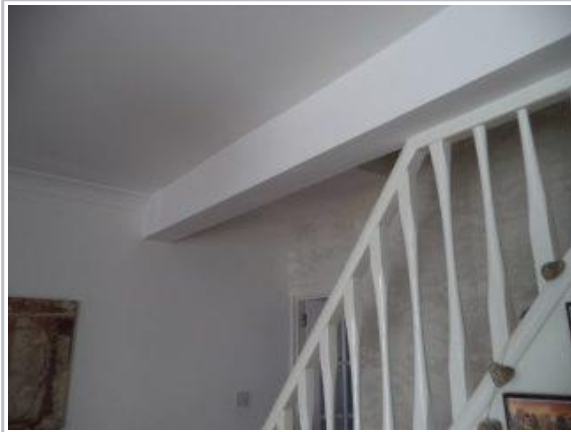
Wall removed in dining room

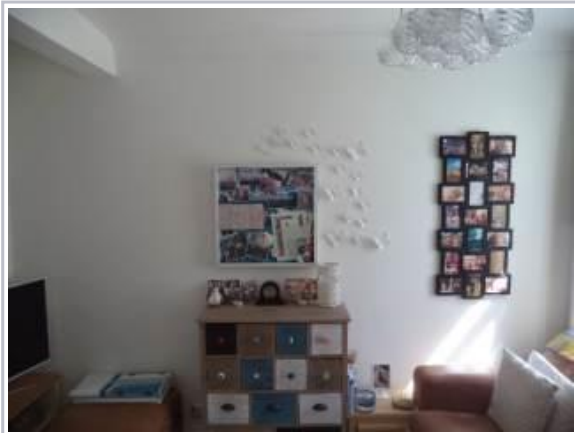
Chimney removed in dining room

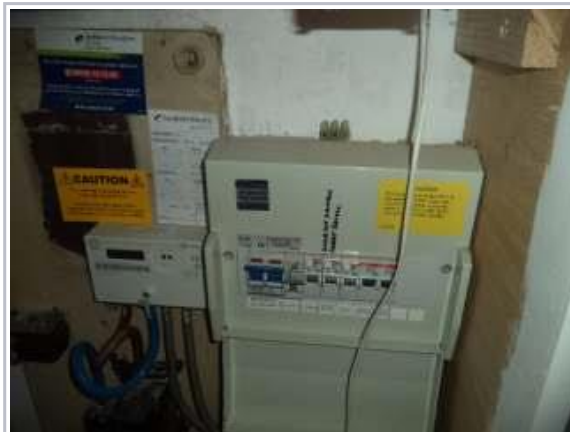
Electrics

Electrical wiring is covered by the insulation in the roof space. The wiring should be above the insulation to avoid over-heating creating a fire hazard.

There are exterior cables situated in the rear garden leading to the shed and garden socket. These appeared to be satisfactory as they are connected to a separate circuit on the consumer unit and are fitted with armoured cables. However, a general electrical check should be carried out if the electrical system has not been inspected recently.

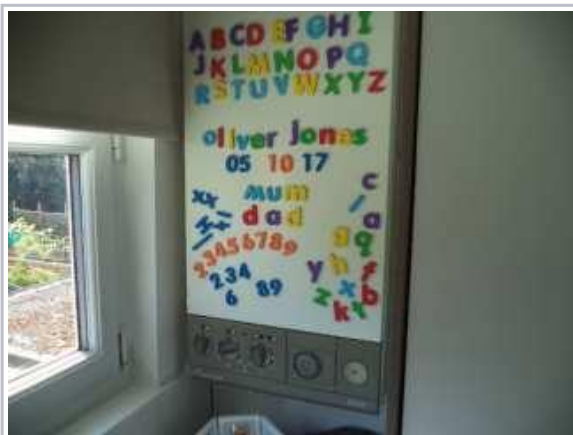
Boiler

Carbon monoxide detectors should be placed close to the gas boiler and changed in accordance with manufactures guidelines.

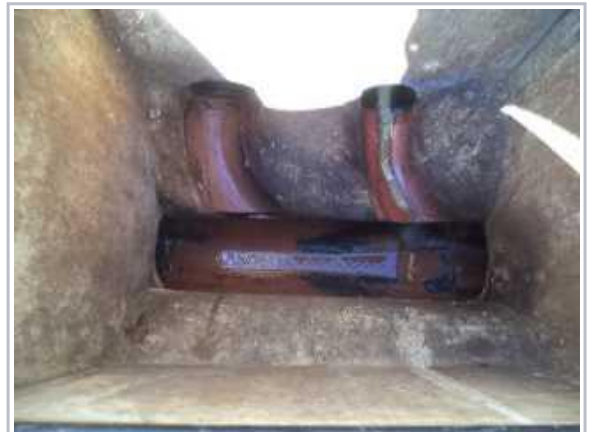
Drains clear where visible

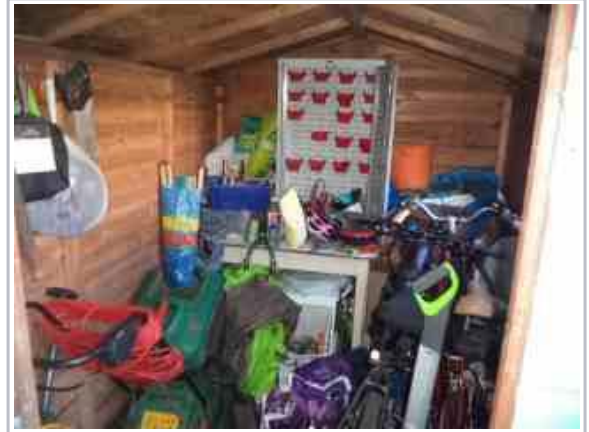
Shed full
